Improvement of Horizontal Line Defects in MicroLED Displays

Abstract

Horizontal lines were discovered during the reliability test of micro-LED display. The basic reason is the short of metal lines with different voltages owing to edge design and film structure. By optimizing process flow and backplane design, the defect is significantly improved. Furthermore, several suggestions of design have been proposed.

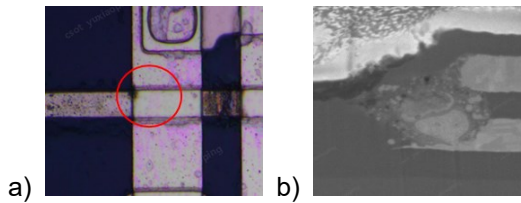
Figure 4. The image of edge short position: a) by OM, b) by SEM

For further analysis, optical microscope (OM) and scanning electron microscope (SEM) are adopted to detect the phenomenon of the short-circuits. As shown in Fig.4, the short on the edge of the panel occurs at the cross position of metal lines with different voltage, such as VSS-gate or data-gate, which is proved by SEM. This type of short is caused by water vapor corrosion, owing to the insufficient protection of the encapsulation of micro-LED panel. The actual voltage of gate is pulled down by the voltage of VSS or data, so the effective voltage of pixel is lower than expected, leading to lower brightness so much as totally darkness. Meanwhile, the short affects the next pixel charging, and finally causes horizontal gradient line defect. The other type of the short inside micro-LED panel is caused by the steep taper of metal line and the thin passivation layer between data and gate lines or gate and VSS lines. As shown in Fig.5, the passivation film is only about 2000Å. If big particle is dropped during the CVD process of the passivation film, short circuit easily occurs as the electric current flows into metal lines. The effective method is to reduce the taper of metal lines and increase the thickness of passivation film.

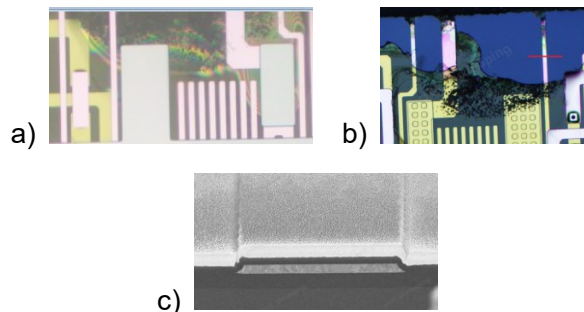
Figure 6. The image after laser cut: a) before separation, b) after separation by OM, c) by SEM

To improve the horizontal line defect, we analyze the path of the water vapor corrosion. As illustrated in Fig.6a, after the laser cut process, the cell test lines extend to the edge of panel. The passivation film is damaged during laser cut process, leading to a gap between passivation film and substrate glass, so much as the passivation film probably is separated from substrate glass as Fig.6b. The passivation film separated from glass is proved to be organic PLN film by SEM as Fig.6c. Water vapors invade along the gap after passing through the outer layer of encapsulation films, and corrode the Cu lines, which leading to the short as the corrosion becomes more and more serious. The damage is caused by the thermal effect during infrared laser cut process, and we suppose that the less thermal effects the less damage. So, we try different cutting methods and the damage is barely observed by UV laser cut with much less thermal damage.
