Effect of Electroplating Additives on Copper Protrusion of Metallized Through-Glass Vias (TGVs)

Abstract

Glass demonstrates exceptional high-frequency performance due to its superior dielectric properties. This work proposes impurities from additives cause vacancies, which, under thermal stress due to CTE mismatch between Cu and glass, aggregate and lead to Cu protrusion of TGV-Cu. Reducing impurity can minimize protrusion, enhancing the reliability of TGV-Cu structures.

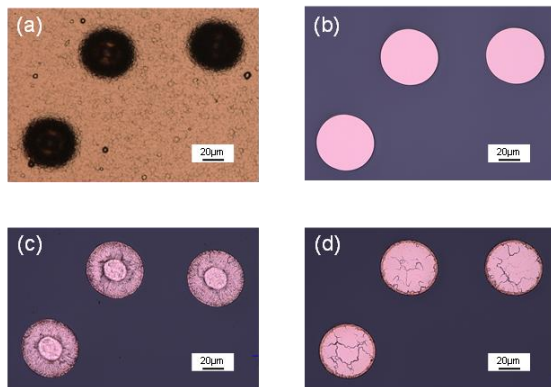
The surface morphology of TGV₁-Cu and TGV₂-Cu is characterized using an optical microscope (OM) before and after heat treatment. After heat treatment, noticeable global Cu protrusions are observed in TGV₁-Cu wafers, while local Cu protrusions are detected in TGV₂ wafers. **Figure 3(a)** shows the top view of Cu vias after electroplating, and **Figure 3(b)** presents the top view of Cu vias after CMP. Following heat treatment at 350 °C, **Figure 3(c)** illustrates the top view of TGV₁ wafers with evident global protrusions of TGV₁-Cu, while **Figure 3(d)** shows the top view of TGV₂ wafers, revealing local protrusions of TGV₂-Cu.

Figure 3. (a) Optical microscopic image of the TGV-Cu after electroplating, (b) Optical microscopic image of the TGV-Cu after CMP (before heat treatment), (c) Optical microscopic image of the TGV₁-Cu after 350 °C heat treatment, (d) Optical microscopic image of the TGV₂-Cu after 350 °C heat treatment.

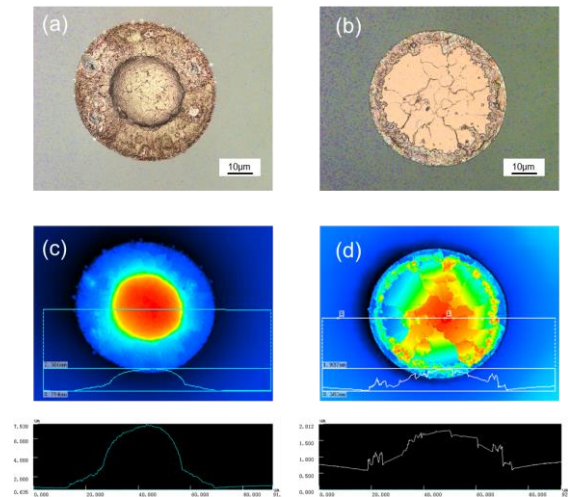
To quantify and compare the protrusion heights of TGV₁-Cu and TGV₂-Cu, measurements are taken using confocal laser scanning microscopy (CLSM). Figure 4(a) and 4(b) show 2D laser images of TGV₁-Cu and TGV₂-Cu after heat treatment, respectively. For 3D morphology profiling, the laser is set to vertical scanning mode, and the height profiles are extracted along the centerline of the TGV-Cu columns, as shown in Figure 4(c) and 4(d). The results

indicated significant Cu protrusions in both samples relative to the surrounding glass substrate. The average global Cu protrusion height in TGV₁-Cu is 6.826 µm, while the average local Cu protrusion height in TGV₂-Cu is 0.875 µm. A comparison between the two samples revealed that the protrusion heights of TGV₁-Cu are substantially higher than those of TGV₂-Cu, suggesting distinct mechanisms for global and local protrusions. The greater protrusion heights imply a higher risk of inducing structural distortion and fracture around the TGV, highlighting the importance of investigating the underlying mechanism of Cu protrusion.

Figure 4. CLSM laser images of (a) TGV₁-Cu and (b) TGV₂-Cu. CLSM image of 3D morphology and height profiles of (c) TGV₁-Cu and (d) TGV₂-Cu after 350 °C heat treatment.

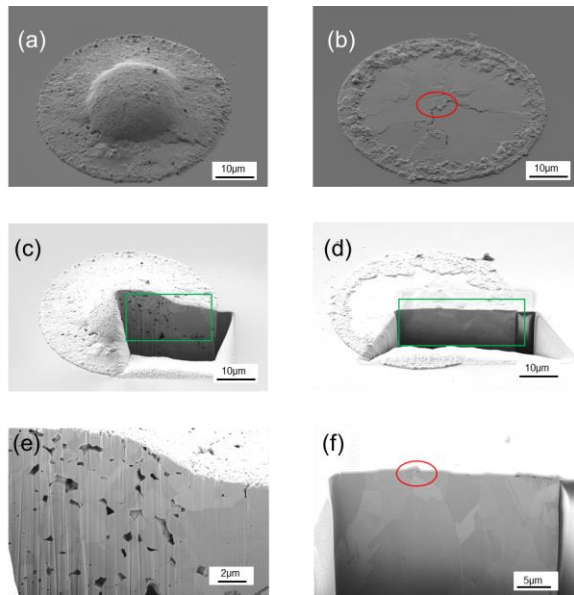
The surface and cross-sectional morphologies of TGV₁-Cu and TGV₂-Cu vias are further analyzed using FIB-SEM, as shown in Figure 5. After the 350 °C heat treatment, Figure 5(a) and (b) confirm the presence of pronounced global Cu protrusions in TGV₁-Cu and local Cu protrusions in TGV₂-Cu, respectively. The Cu surfaces after CMP appeared flat. The protrusion height in TGV₁-Cu increased towards the center of the vias, reaching nearly 7 µm, consistent with CLSM measurements. In contrast, the protrusion height in TGV₂-Cu is smaller. Figure 5(e) reveals that the global protrusions in TGV₁-Cu consisted of numerous Cu grains and voids, with the void density increasing towards the center of the vias. Figure 5(f) shows that the local protrusions in TGV₂-Cu comprised several Cu grains, with the protrusion boundaries aligning with the grain boundaries at the top region of the TGV-Cu, as indicated by red circles in Figures 5(b) and 5(f). Notably, no voids are observed in TGV₂-Cu.

Figure 5. Surface SEM results of TGV-Cu in (a) TGV₁-Cu and (b) TGV₂-Cu after 350 °C heat treatment before FIB milling. SEM images of TGV-Cu in (c) TGV₁-Cu and (d) TGV₂-Cu after FIB milling. Cross-section SEM images of TGV-Cu in (e) TGV₁-Cu and (f) TGV₂-Cu.

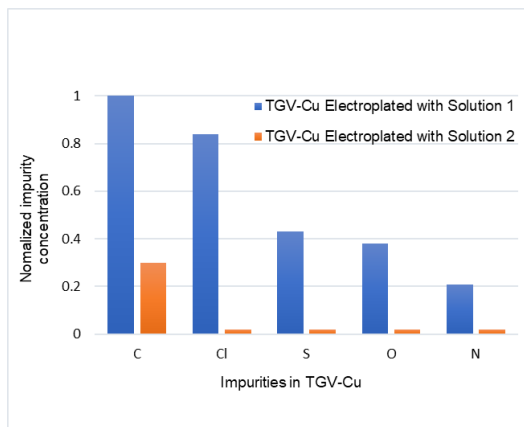
Energy dispersive X-ray spectroscopy (EDX) analyses, shown in **Figure 6**, demonstrated a significant contrast in impurity concentrations (C, Cl, S, O, N) between TGV₁-Cu and TGV₂-Cu. TGV₁-Cu exhibited much higher impurity levels, likely due to the differences in electroplating additives (Additive 1 and Additive 2).

Figure 6. EDX analyses for normalized impurities concentration of TGV₁-Cu and TGV₂-Cu.

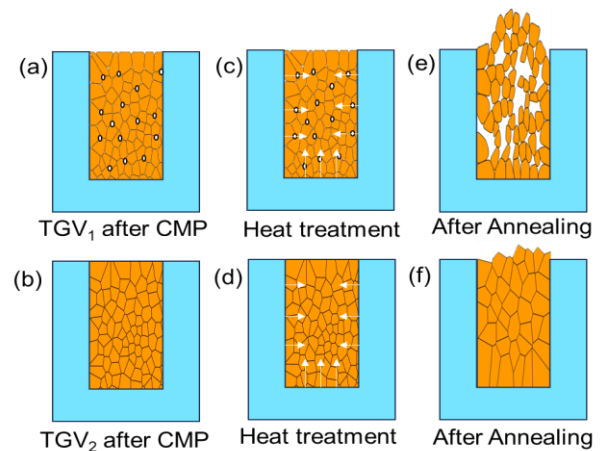
To further explore the mechanisms underlying Cu protrusion, two types of Cu protrusions are analyzed from the perspectives of impurity incorporation, induced thermal stress, and vacancy aggregation. During the electroplating of TGV₁-Cu, impurities originating from the organic substance in the plating solution (Additive 1) co-deposited with Cu.⁹ This impurity incorporation increases atomic disarrangement, leading to the formation of numerous vacancies within TGV₁-Cu that aggregates along Cu grain boundaries, as illustrated in **Figure 7(a)**. In contrast, substituting the additive leads to minimal impurity incorporation in TGV₂-Cu, resulting in fewer vacancies, as shown in **Figure 7(b)**.

Figure 7. Schematic of microstructures in (a) TGV₁-Cu and (b) TGV₂-Cu at the initial state after CMP. Schematic of microstructures during heat treatment in (c) TGV₁-Cu and (d) TGV₂-Cu. Schematic of microstructures after annealing at 350 °C in (e) TGV₁-Cu and (f) TGV₂-Cu. White arrows indicate the direction of thermal stress exerted on TGV-Cu by the surrounding glass substrate.

The initial TGV-Cu structures nearly possess a stress-free state after CMP at room temperature. During the heat treatment at 350 °C, TGV-Cu and glass substrate tend to expand due to the increase of atomic thermal vibration at high temperature. Due to the large CTE mismatch between Cu and glass, the free expansion of TGV-Cu is locked by the surrounding glass. This trend can lead to an axial and radial compressive stress exerted on TGV-Cu, as illustrated by the white arrows in **Figure 7(c)** and **7(d)**. The vacancies distributed along the Cu grains boundaries can be driven to migrate from edge to center by the axial and radial thermal stress, and void formation in center is induced by the aggregation of vacancies. This can explain the phenomenon that global protrusion and voids in center of TGV₁-Cu, as shown in **Figure 7(e)** and **Figure 5(e)**. In addition, as the temperature of heat treatment is 350 °C, thermal stress is large enough to induce plastic deformation of Cu, and local plastic deformation occurs in the TGV-Cu, as shown in **Figure 7(f)** and **Figure 5(f)**. The difference of additives in plating solution between TGV₁-Cu and TGV₂-Cu is the reason for different Cu protrusion behaviors in the TGV-Cu.

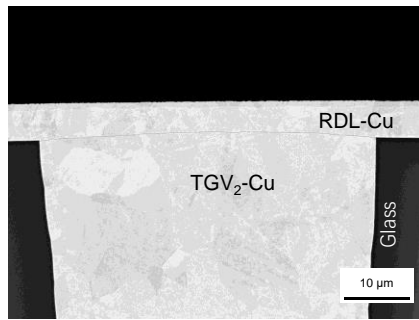
Figure 8. Cross-section SEM results of TGV₂-Cu structure with RDL after 350 °C heat treatment.

To maintain the mechanical and electrical interconnections between TGV-Cu and the redistribution layer (RDL), it is crucial to prevent Cu protrusion after heat treatment. Based on the findings, optimizing the plating solution additives is essential to minimize impurity and vacancy concentrations in TGV-Cu. A TGV₂-Cu structure integrated with RDL is fabricated, and after heat treatment at 350 °C for 1 hour, cross-sectional SEM characterization is performed, as shown in **Figure 8**. The results demonstrate a strong bond between TGV₂-Cu and the RDL, indicating that optimizing the additives effectively can mitigate Cu protrusion.
