Research on the Causes of OLED White Spot Defects and Exploration of Improvement Directions

Peng Feng, Shuibin Ni, Xing Feng, Lei Wang, Yiwen Liu

* Chengdu BOE Display Technology Co., Ltd, Chengdu, China

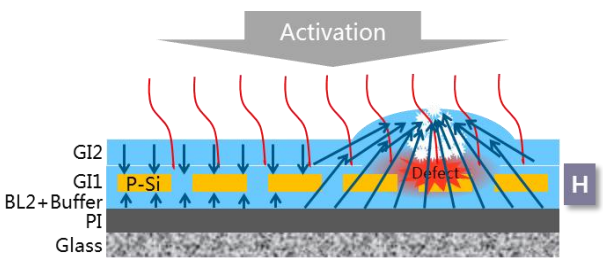
Figure 4. Mechanism of implant affecting white spot

Defects within the layers can cause a negative offset in the V_{th} of the pixels around them through two main mechanisms. Mode 1 involves affecting V_{th} Doping, as shown in Fig. 4. During the V_{th} doping process, the defect forms a micro field with the defect at its core, causing the B^+ ions to deviate from their intended paths or blocking ion implantation at the Poly-Silicon surface, ultimately leading to reduced ion dosage in the defect and its surrounding area, thus causing the electron hole of PMOS TFT decreased, leading to V_{th} negative offset. Mode 2 affects activation, as shown in Fig. 5. During the activation process, defects encapsulated in dense SiN/SiO deform and expand under high temperatures (over 400 degrees Celsius), which can even break the inorganic film layer. The resulting voids allow H^+ ions to escape due to the concentration gradient, reducing the hydrogen content in the defect and its surrounding area, thus causing the electron hole of PMOS TFT decreased, leading to a V_{th} negative offset.

From the Mode 1 analysis model in section 2.3, we know that the ion implant process is a trigger for white spots. We propose two experimental conditions for the ion implant process. Split A: Perform ion implant after ELA to reduce the impact of defects produced after Multi on ion implant; Split B: Keep the ion implant site unchanged but increase the implant concentration to positively adjust the overall V_{th} . Products are validated to the lighting judgment under these two conditions, with four G6 Glass pieces for each condition and an additional four pieces produced under mass production conditions for comparison.

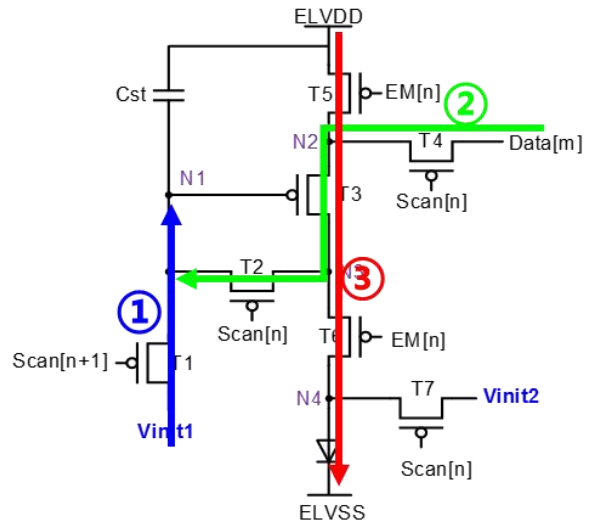
Figure 6. White spots causing by V_{th} negative bias

When T3 V_{th} continues to be negatively biased and V_{init1} $V_{data} > V_{th}$, stage ② signal cannot be written, and compensation & signal writing fails. If the I_{ds} of stage T3 remains between I_{off} and I_{Vth} and cannot be turned off or turned on normally, a white spot will form, as shown in Fig.
